CONNECTICUT RIVER BASIN
GRAFTON, NEW HAMPSHIRE

GRAFTON POND DAM

PHASE I INSPECTION REPORT
NATIONAL DAM INSPECTION PROGRAM

NOVEMBER 1978

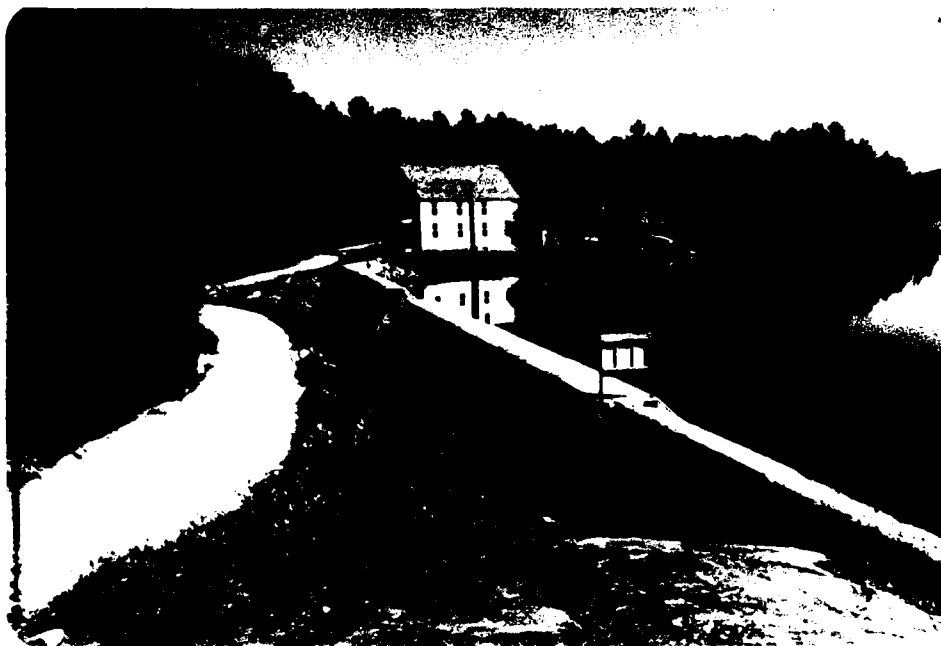
Overview from left abutment showing
bedrock outcrop

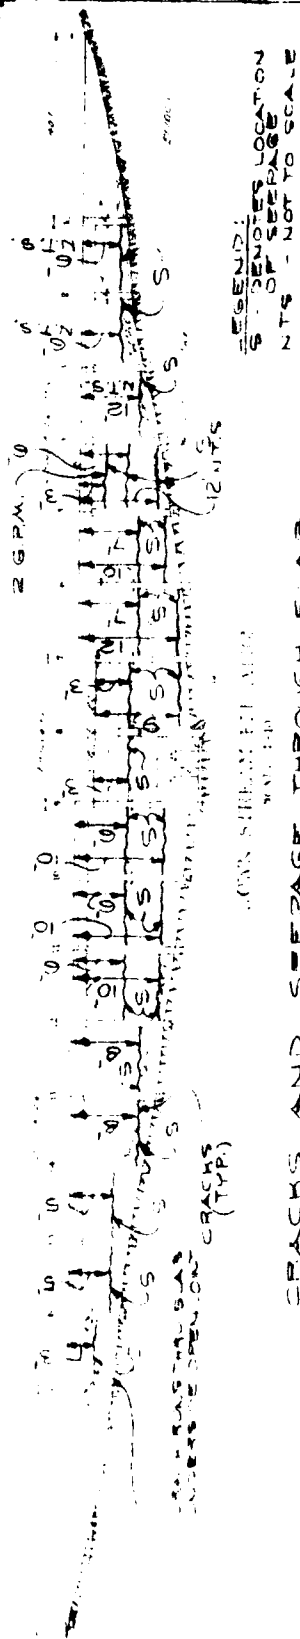
GENERAL PLAN AND ELEVATION
AMBERSEN DAM
GRANTON POND - MASCUMA RIVER

CRACKS AND SEEPAGE THROUGH SLAB
